DILAPIDATION INSPECTION REPORT

AS4349.1-2007

28/01/2020

44 Sample Close

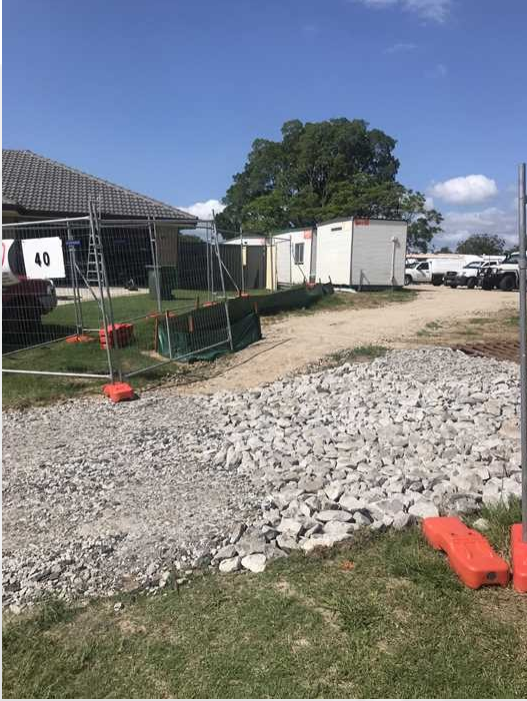
Image 1: Construction site and heavy earthmoving. See truck entry point.

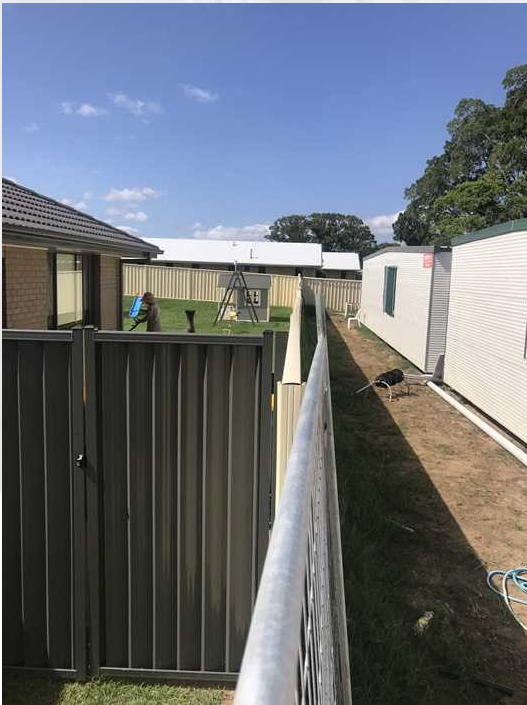
Image 2: Construction estimated to concede July 2022.
Minor deviation of west side fence line, Bordering construction site
